Workshop on "Mechanisms of Copper Corrosion in Aqueous Environments" 16<sup>th</sup> of November 2009

# **Thermodynamics and kinetics of copper corrosion in oxygen free water**

**Ph. D. Peter Szakálos, KTH**

**Associate Prof. Olle Grinder, KTH**

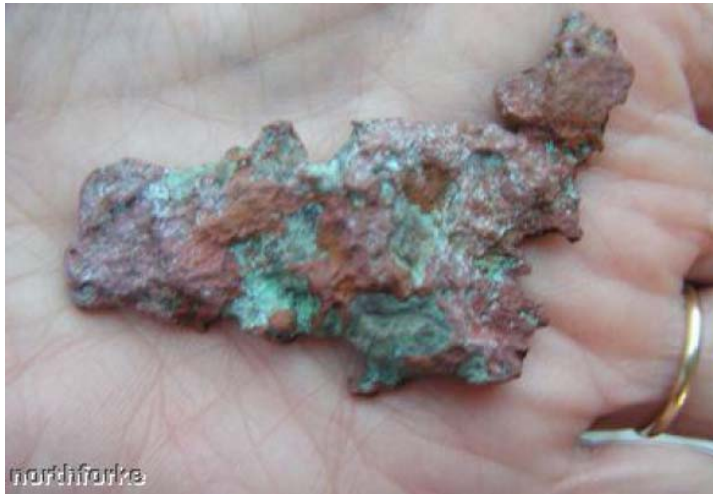
Native copper from Keweenaw  
Peninsula, Michigan, USA.  
(SSM-report 2009:28)

**It has been claimed that copper canisters should be corrosion resistant since native copper is found at some few locations in the world. However, the situation is the same for native iron (and nickel, zinc etc) but no one is using this argument to state that iron should be corrosion resistant in groundwater! (Groundwater contains chlorides, sulphides, sulphates and methane/acetate etc)**

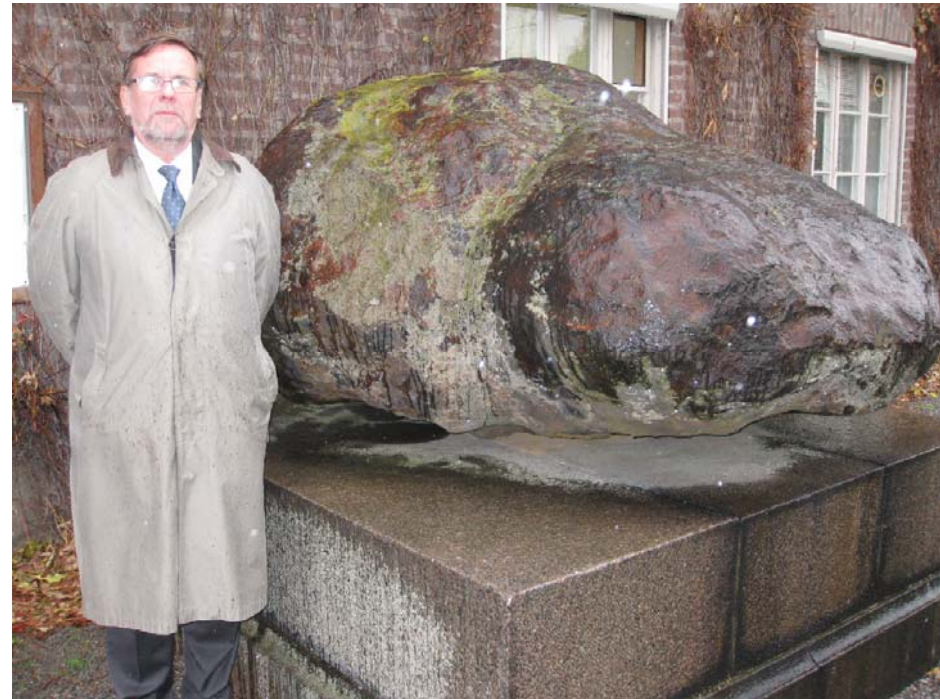
Native iron from Ovifak on Disko island,  
Greenland (22 ton boulder). Found by the  
explorer A. E. Nordenskiöld 1870. (The  
Swedish Museum of Natural History)

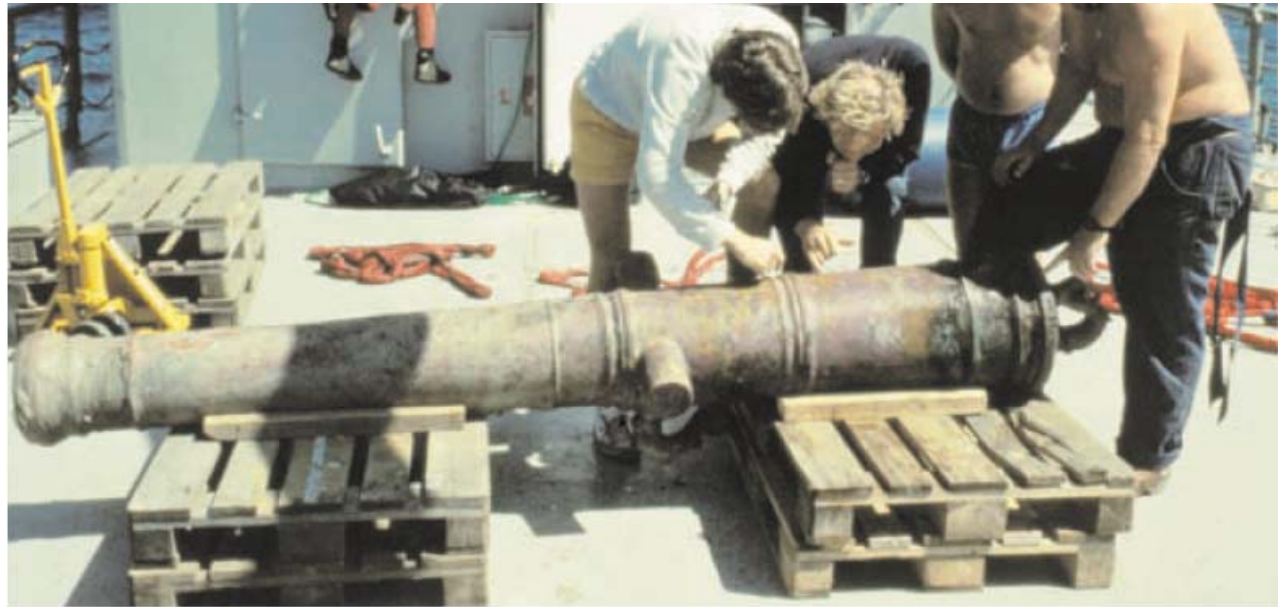
En av regalskeppet Kronans kanoner omedelbart efter bärgningen.

**The corrosion of bronzes differs fundamentally from that of copper. An enrichment of passivating tin forms on the bronze surface that strongly reduces the corrosion rate in aqueous environments, this was known already 30 years ago.**

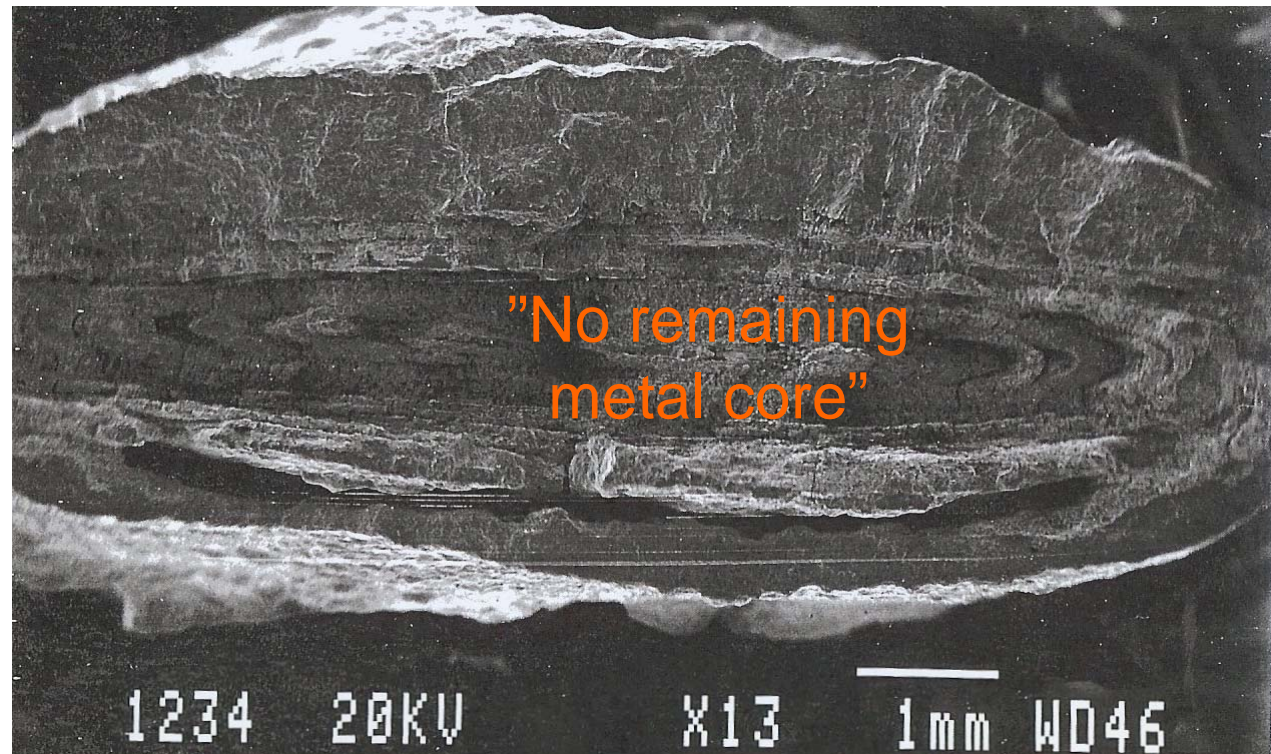
Copper coins on  
*Kronan* were more  
corroded than on  
*Wasa* and several  
*Kronan*-coins had  
no remaining  
metal core left

Fracture surface of a copper compass ring from the warship *Kronan*, wrecked in the Baltic sea 1676. 100% copper sulphide.

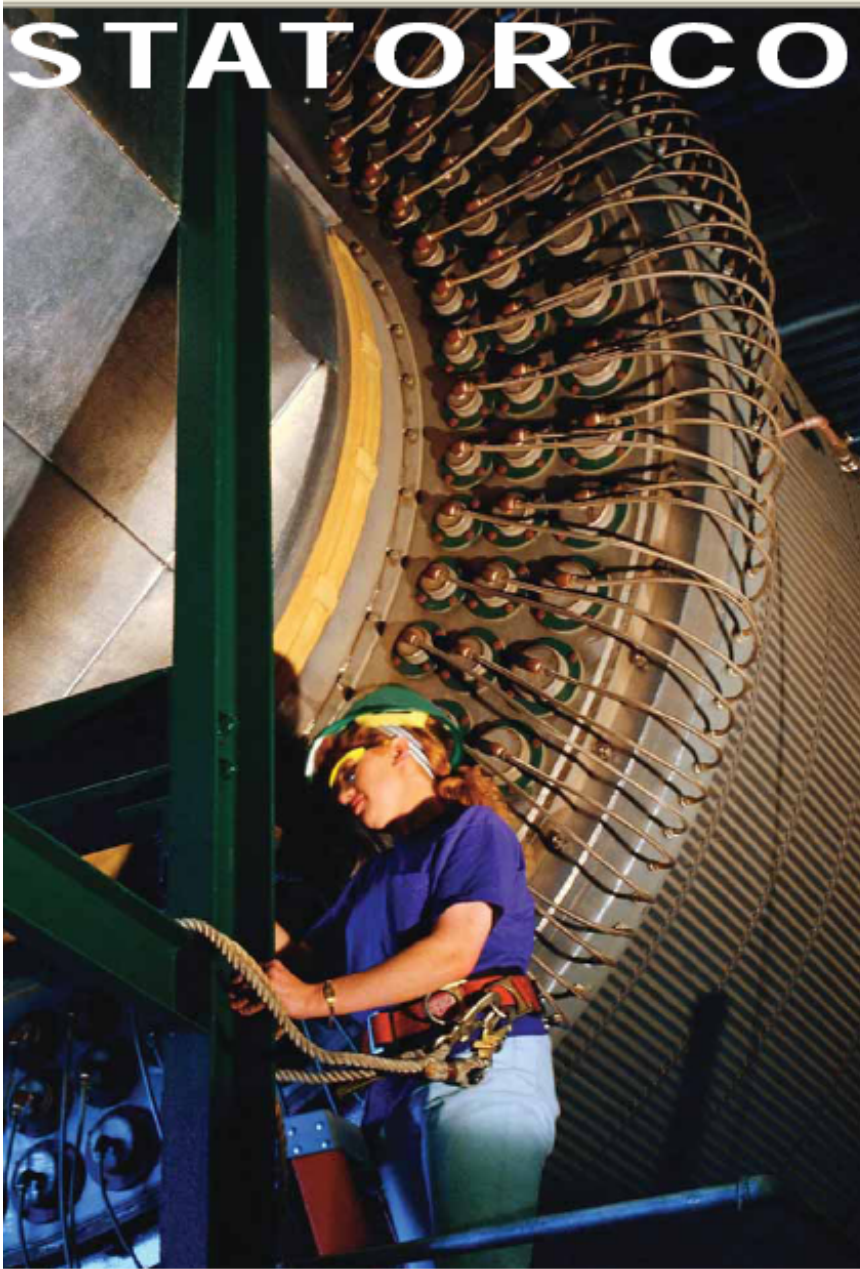
Corrosion in the stator cooling system of power generators is a primary source of maintenance costs and plant downtime.

Copper corrosion in O<sub>2</sub>-free water is a well known industrial problem.

All copper cooling system for power generators and accelerators (CERN etc) corrodes (0.5-10µm/y)

Environment: Deionised and degassed water around 70°C

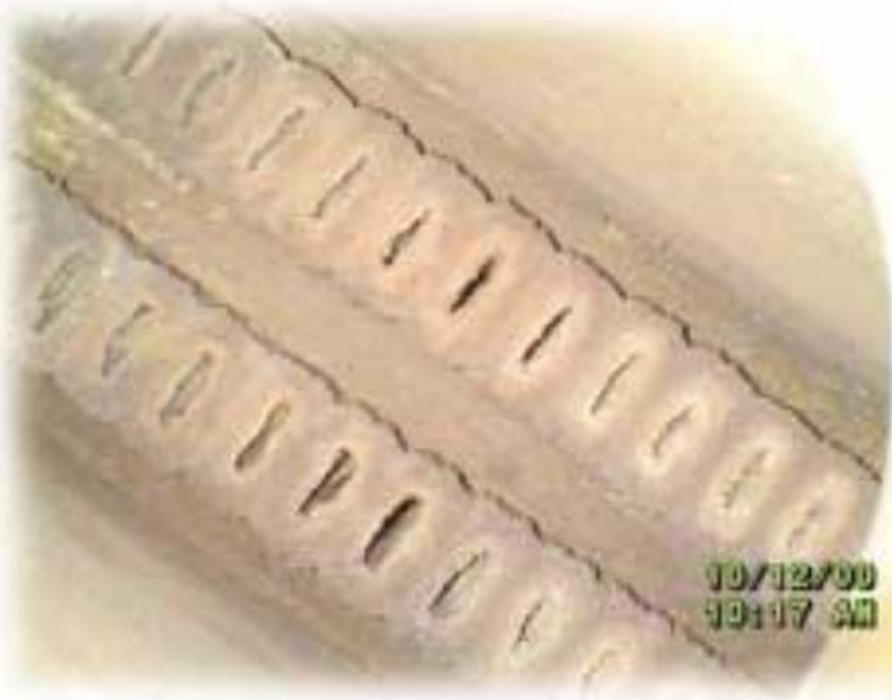
*Figure 1. Partial plugging by copper corrosion products (oxides and hydroxides) prior to cleaning of water-cooled generator at SONGS 2. Photo courtesy of EPRI*

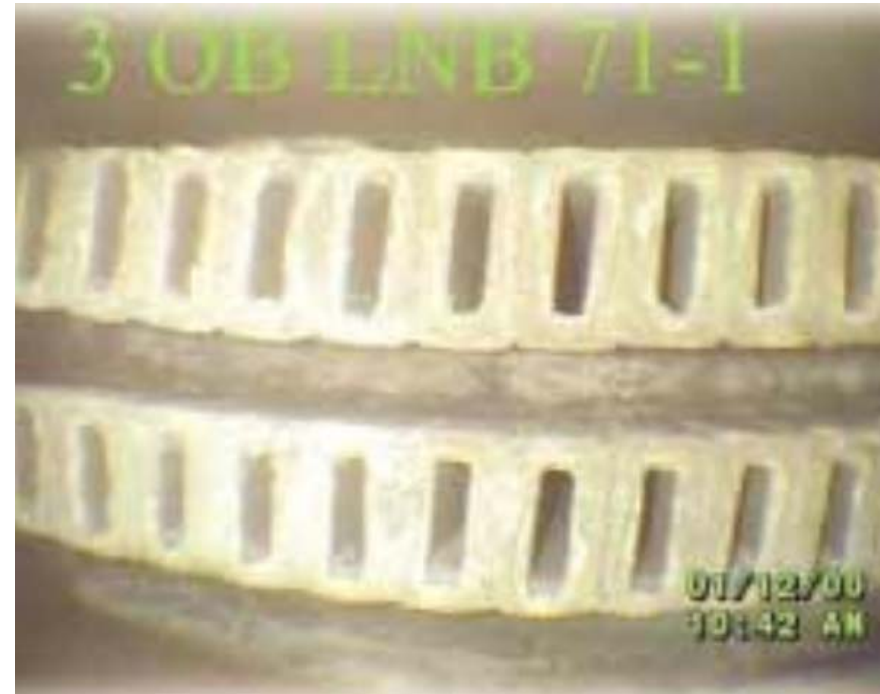
*Figure 2. Videoscopic inspection after Cuproplex cleaning of SONGS 3 water-cooled generator. Photo courtesy of EPRI*

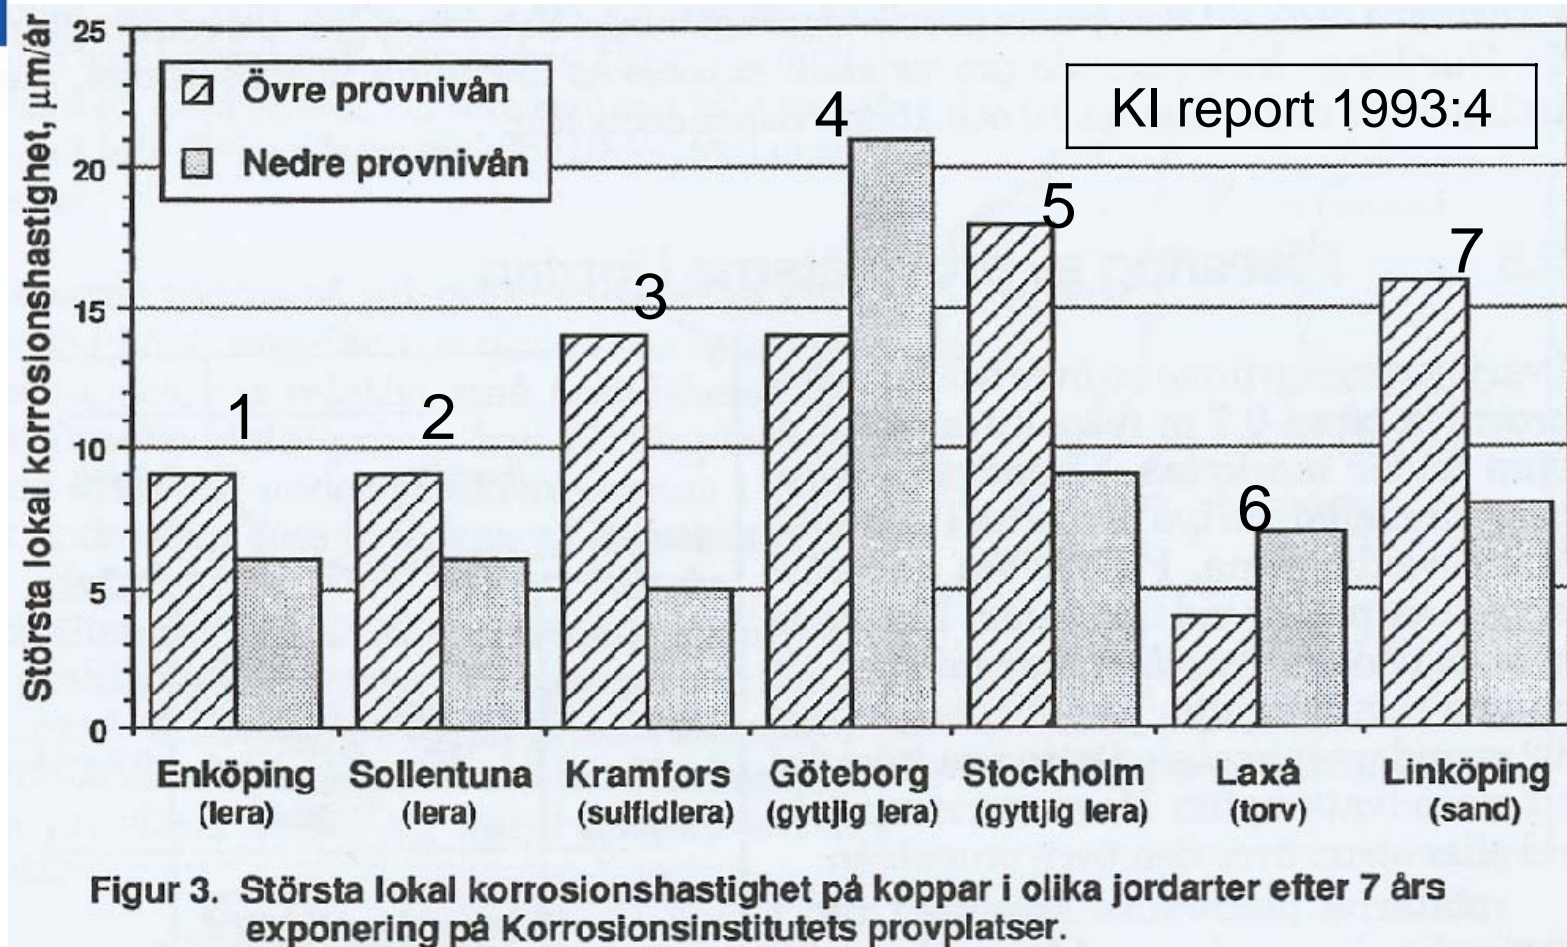
**Low redoxpotentials were recorded in test sites 2, 3, 4 and 5, which indicate O<sub>2</sub>- free corrosion.**

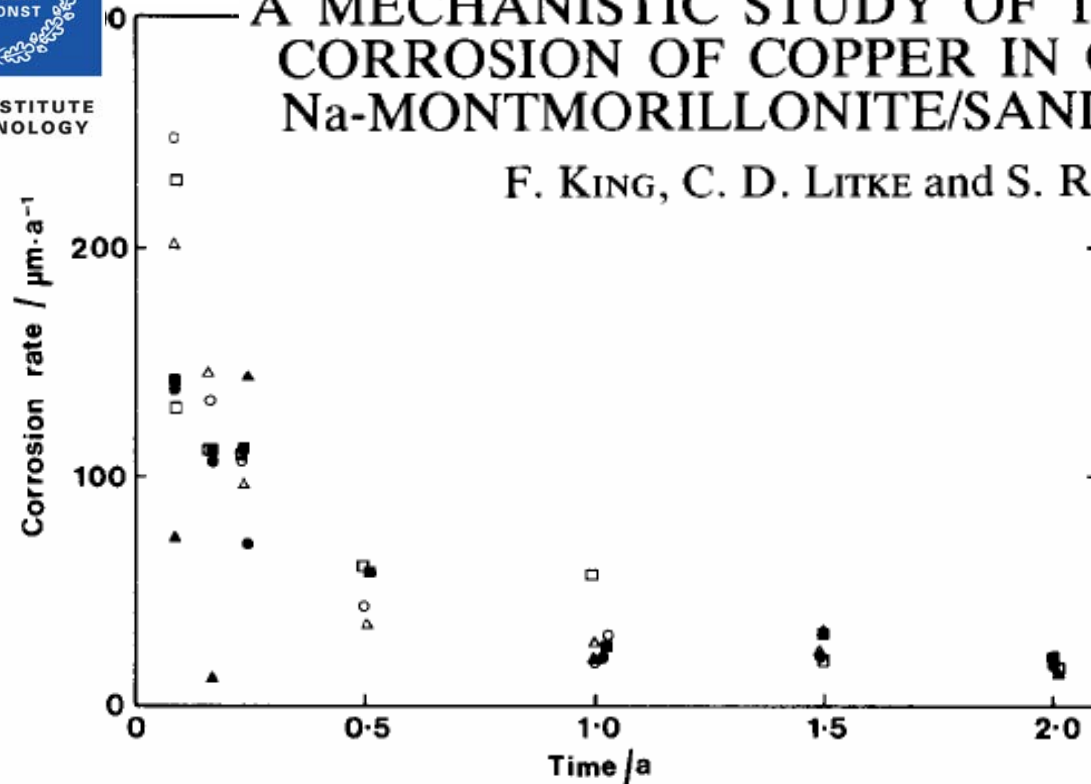
This laboratory study confirm the LOT *in-situ* exposure, i.e. the general corrosion rate of heated copper is 10-20 µm/y. It takes place with a dissolution-precipitation process in contact with bentonite clay/ ground water

FIG. 8. Copper corrosion rates determined from weight loss of coupon in contact with compacted buffer material in absence of  $\gamma$ -radiation. ● 50°C, 1.45 g cm<sup>-3</sup> buffer density; ■ 50°C, 1.65 g cm<sup>-3</sup>; ▲ 50°C, 1.79 g cm<sup>-3</sup>; ○ 100°C, 1.45 g cm<sup>-3</sup>; □ 100°C, 1.65 g cm<sup>-3</sup>; △ 100°C, 1.79 g cm<sup>-3</sup>.

On page 1991, it was concluded that “O<sub>2</sub>-transport was not rate-limiting” and that the corrosion took place with a dissolution–precipitation process; “Precipitation of copper inevitably occurred in all of the tests, with usually more than half of the total copper corroded being in the form of precipitate rather than being sorbed on the clay”.

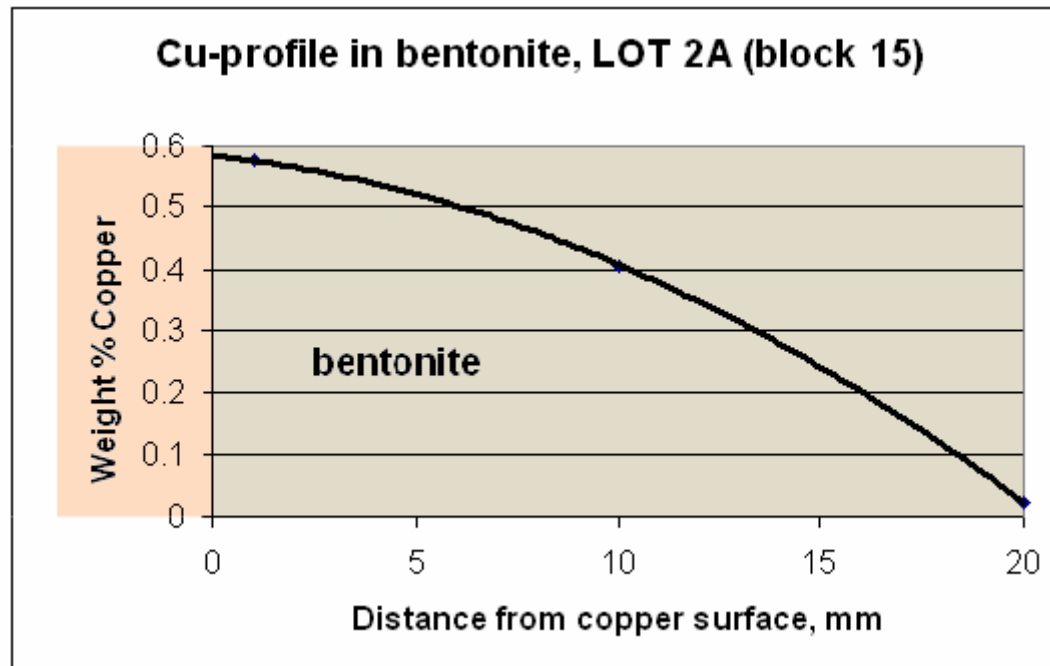
Heated copper  
exposed for 5  
years in the Äspö  
laboratory

A significant part of the copper in bentonite are **precipitated as Cu- and Cu(Fe)-sulphides**, representing ca 4  $\mu\text{m}/\text{y}$  in corrosion rate. Considering the total amount of copper in corrosion product, bentonite and groundwater it is most likely that the copper corrosion rate is **at least 10  $\mu\text{m}/\text{y}$**  (pitting corrosion not taken into account).

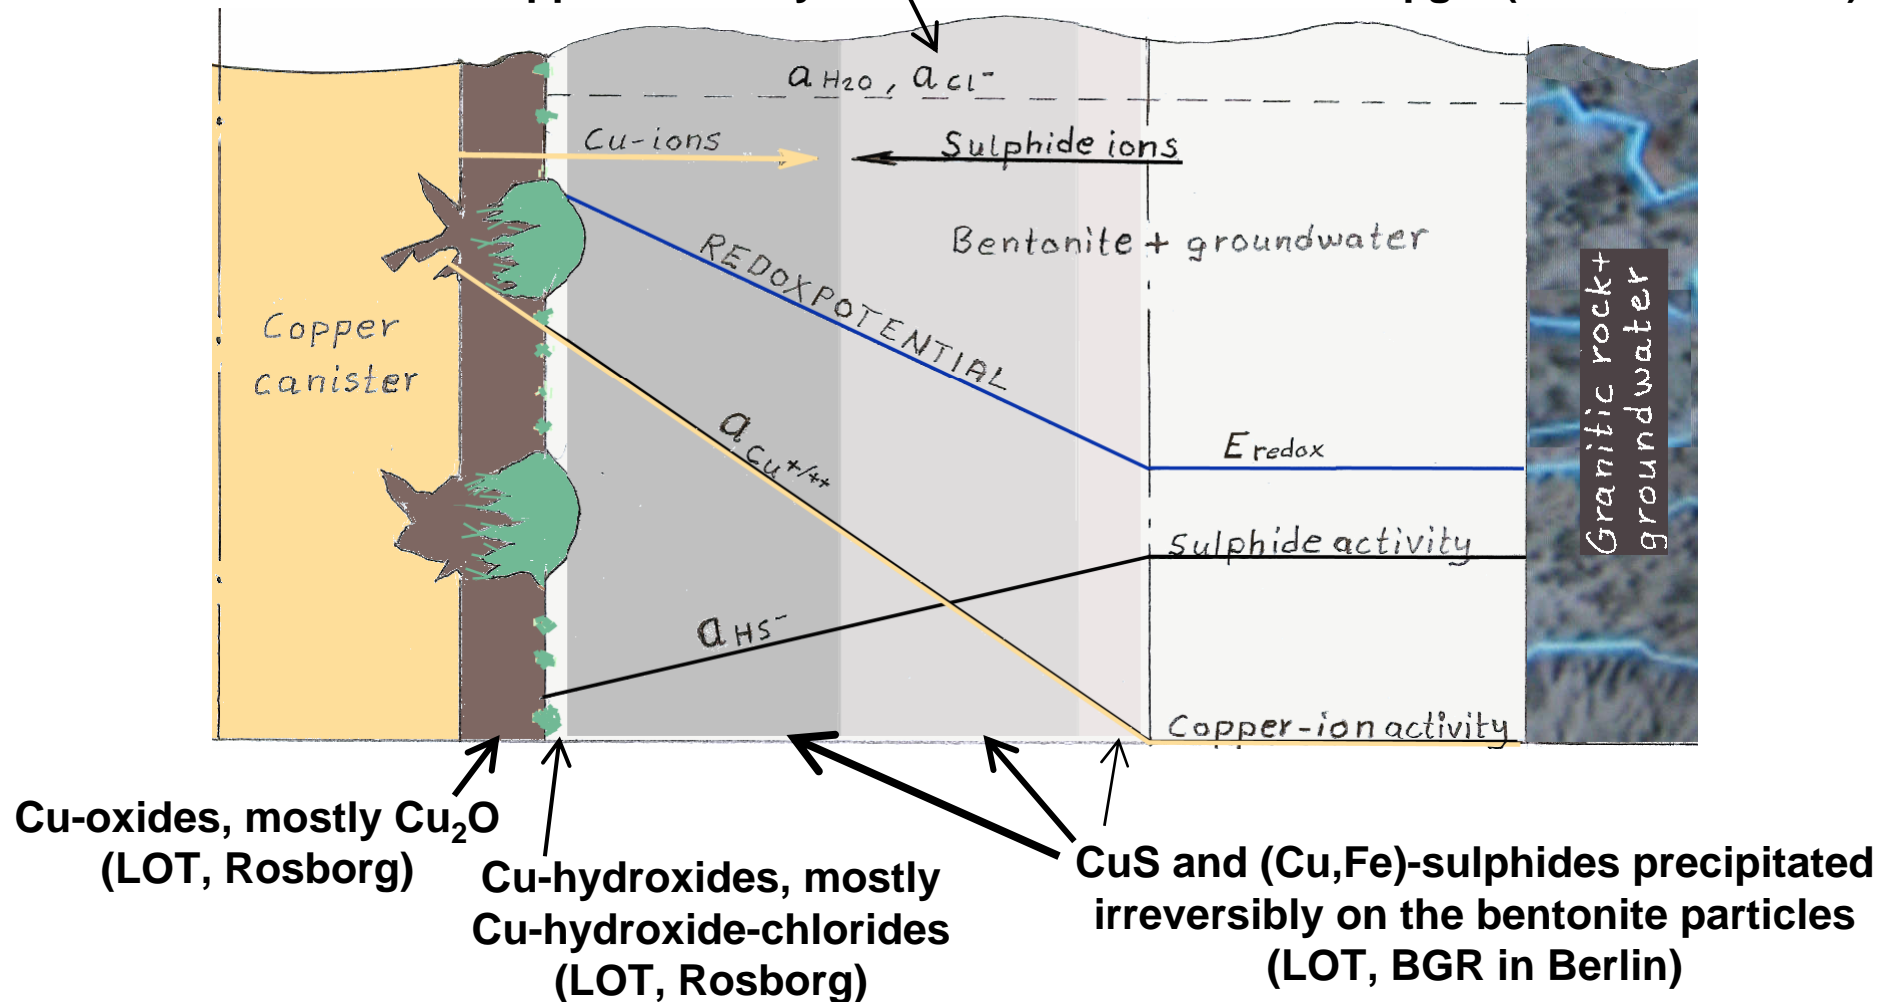
# A corrosion model explaining the observations from the LOT-project; copper exposed in ground water saturated bentonite

Copper solubility in saline water at 80°C: 2300µg/L (POSIVA 2003:45)

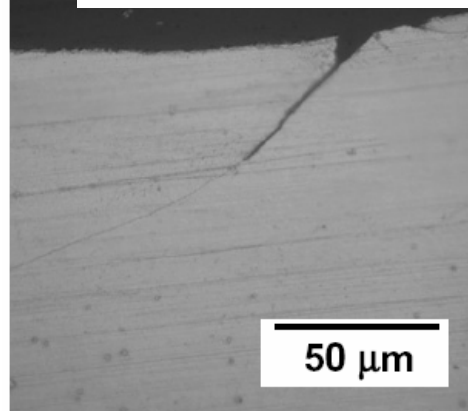
0.001M-Na<sub>2</sub>S

Slow Strain Rate Testing, SSRT:  
Synthetic seawater 80°C without O<sub>2</sub>  
Extension rate: 8.3E-7 s<sup>-1</sup>

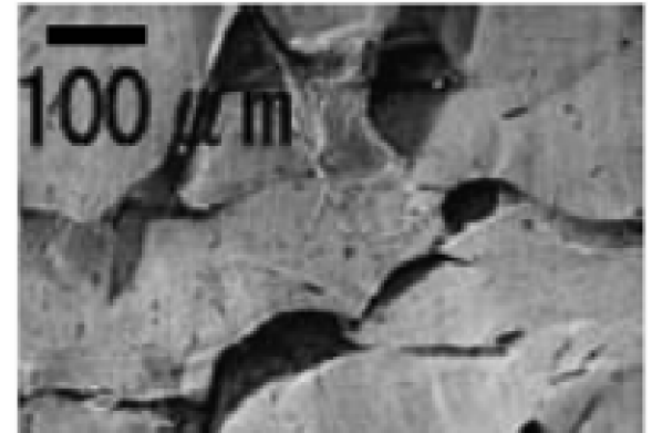
SCC at 80°C on OFHC-Copper with 45ppm P

**SCC is likely to occur within the first 1000 years**
